Somerset Floods 2014

Graham Quarrier
Projects Team Manager

How the Somerset Levels work

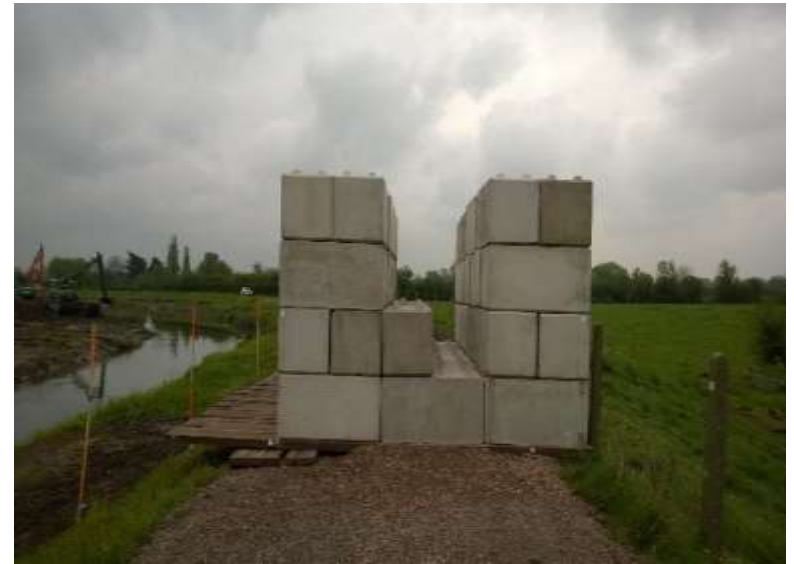
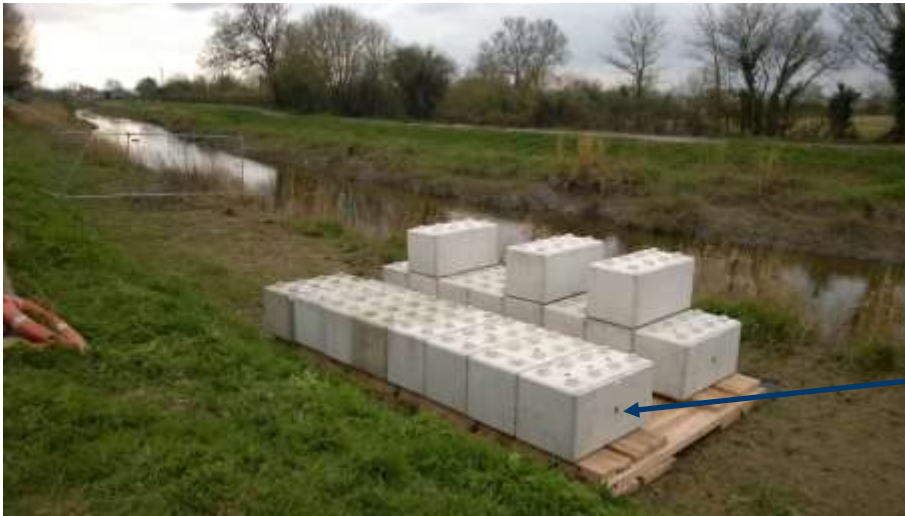
Load testing for
safety

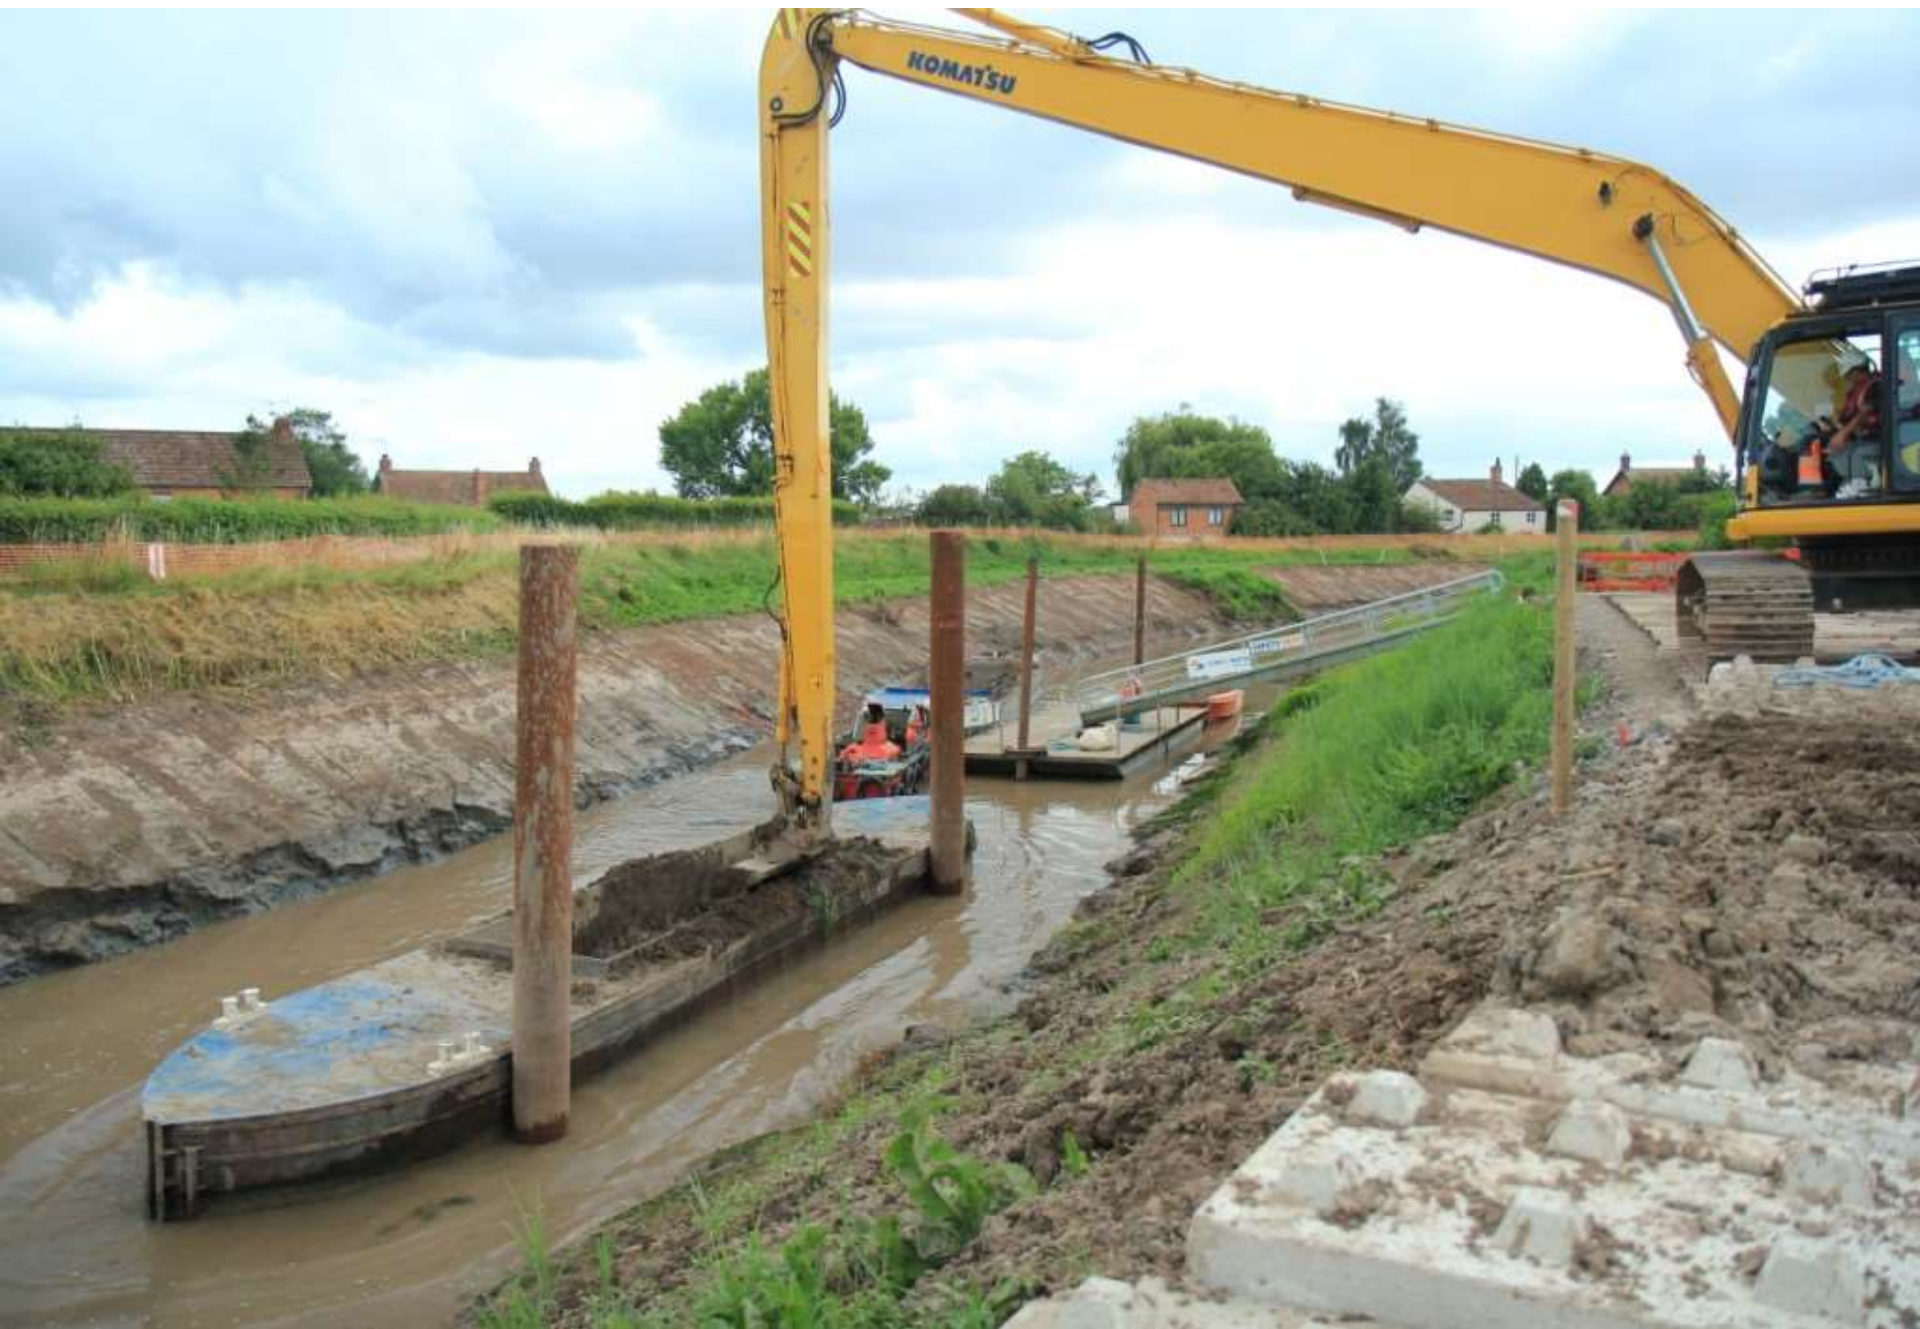
Offloading point

An aerial photograph showing a river restoration project. The river flows from the top left towards the bottom right. On the left bank, there's a temporary weir. Further up the river, there's an offloading point. The right bank features a cluster of industrial buildings and a residential area. A large area of silt is marked for spreading in the fields. Amphibious and bankside dredging is taking place near the bottom right.

Temporary
Weir

Silt to be spread in
fields

Amphibious and
bankside dredging

Rivers Parrett and Tone Dredging

- ➡ 8km reach known to have greatest impact
- ➡ Needed different management approach akin to Incident Management
- ➡ Selected reach definitely worth doing
- ➡ Could have prevented more damage than we realised
- ➡ Evaluation system may not reflect the truth!

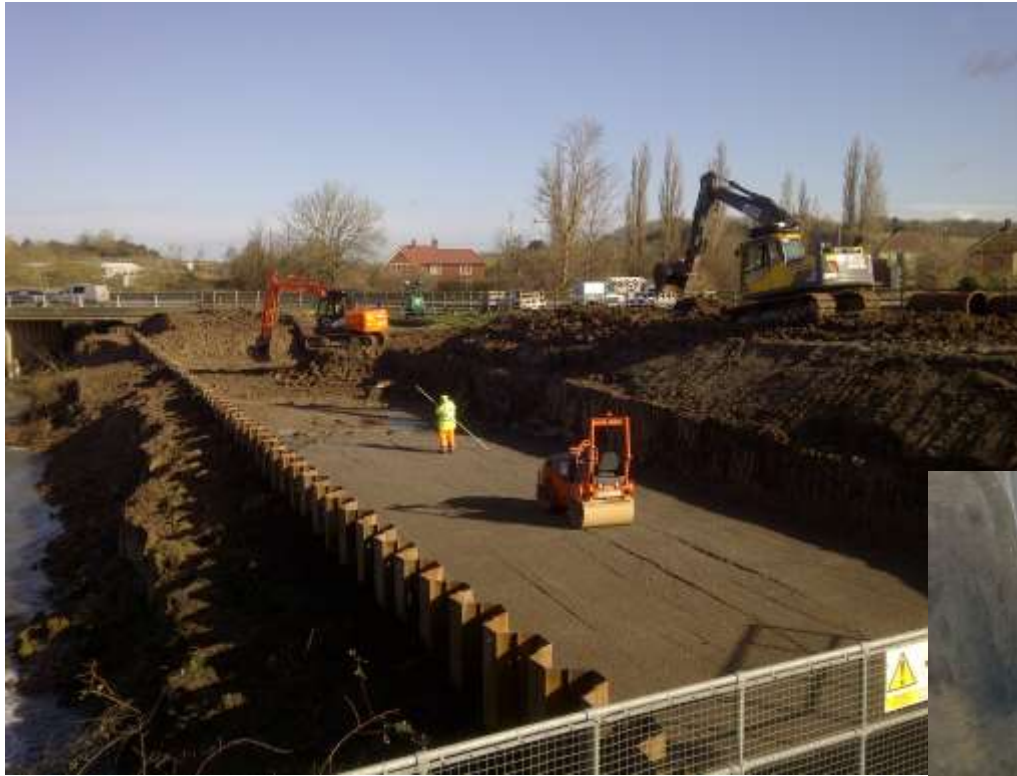
Platform for temporary pumps
when Kings Sedgemoor Drain
is tidelocked

EA will use a mix of owned and
hired pumps for flood events
